## Conservation Plan For Aapravasi Ghat

2006-2011

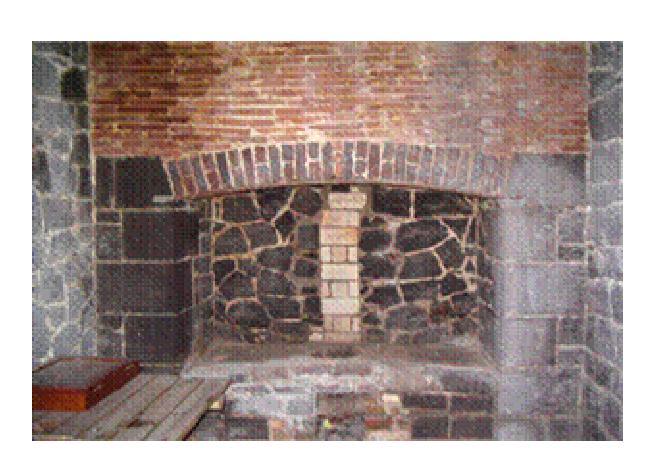
The use of cement in recent times to conceal small cracks at the point of conjunction with the basalt wall has weakened the stress bearing power of the brick feature. This has to be undone to effectively increase the survival age of the chimney.

Original chimney in the kitchen made up og basalt stones and bumt bricks

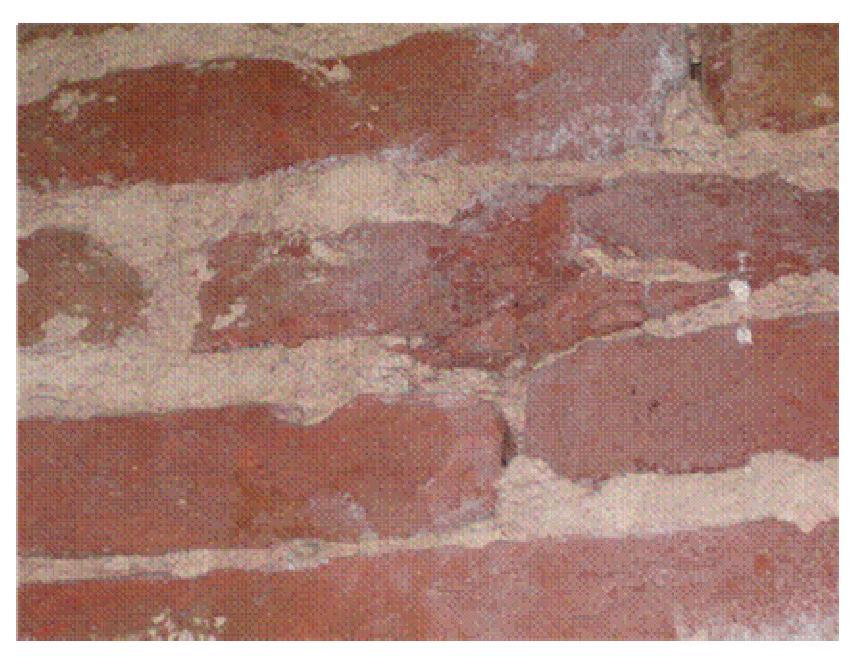
Weathening of some bincks in the chimney.

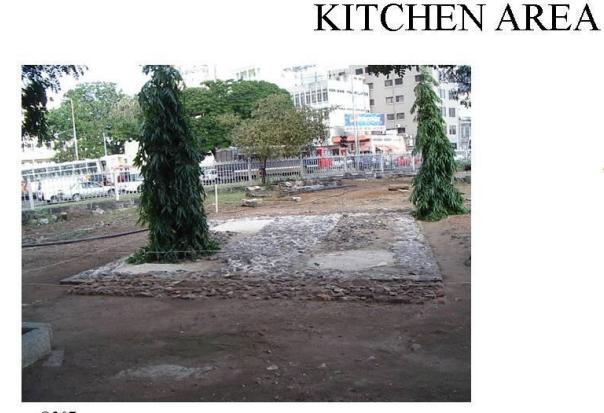
Q207 The ashoka tree which has to be removed and placed back from the site since it is damaging the structure from beneath.

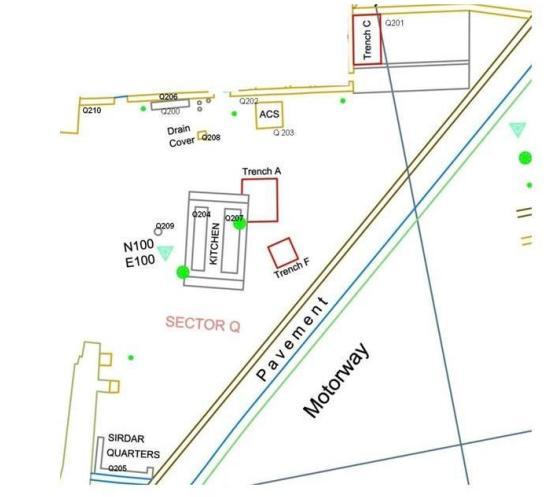
the north-western kitchen. The drain has to be cleaned for proper water channeling.

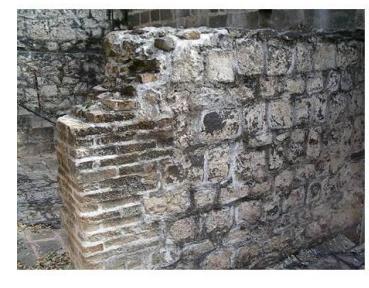
P112 The separation wall of the privies show sins of moisture and algae growth. The separation wall is made up of random stone masonry and burnt bricks

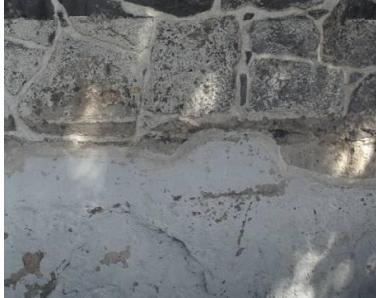
P105 Remaining lime plaster found in the water basins on the eastern side of the privies area. The lime plaster is flaking and crumbling due to its exposure to weather conditions. Edging is being done at present to preserve the remaining plaster

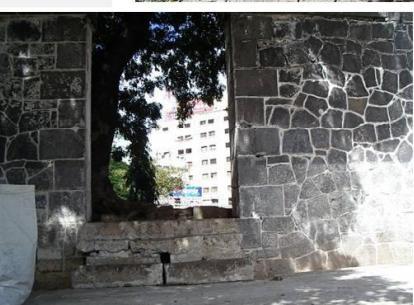
P106 This the stairs leading to the kitchen area. The stones have been disturbed with time. These stones need to be fixed back to their place and consolidated with lime mortar All drawings are to be read only and not scaled
