## Conservation Plan For Aapravasi Ghat

2006-2011

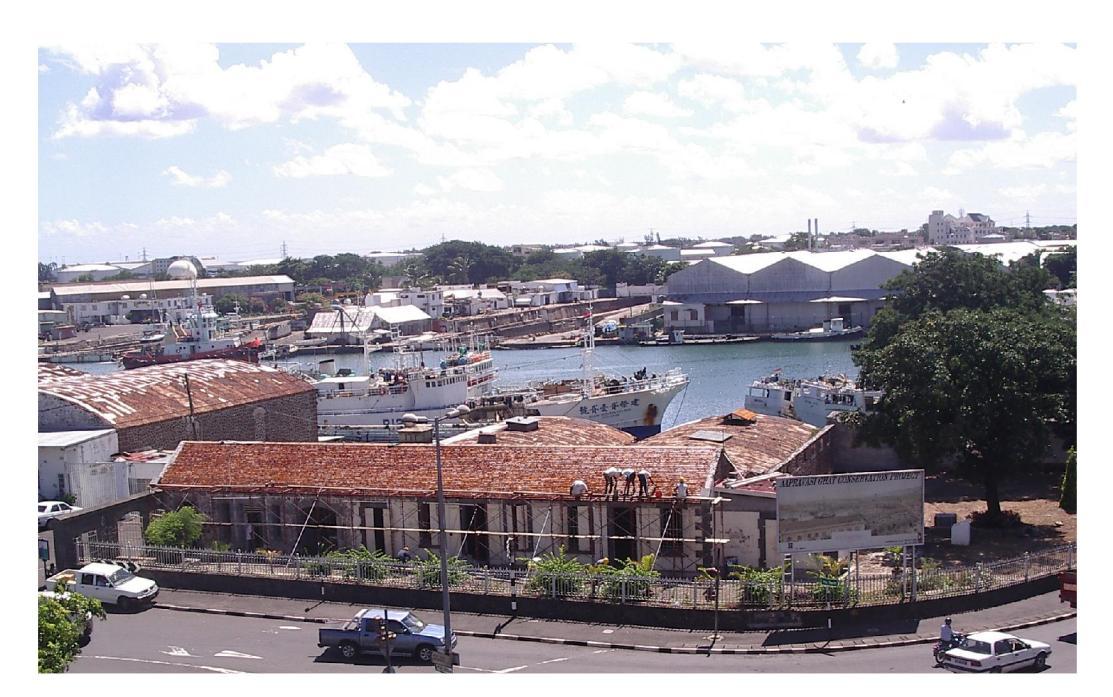
This is a linear structure containing seven rooms. The physical state of the site has revealed that large scale intervention was carried out as an endeavour to modernise the surviving structure during the past decade. In 2000, a new roof was put on the building which unfortunately changed the hospital block's appearance. The use of modern construction materials also compromised the buildings' historical authenticity. The restoration of the hospital block aims at re-establishing the aesthetic and historic value of what is now left of the Immigration depot. The whole restoration process is being carried out after a deep study of 1864 and 1865 archival plans of the building. Modern features such as modern tile flooring in surgery and ward rooms were removed as well as the use of cement components.

The hospital Block Source: AGTF collection

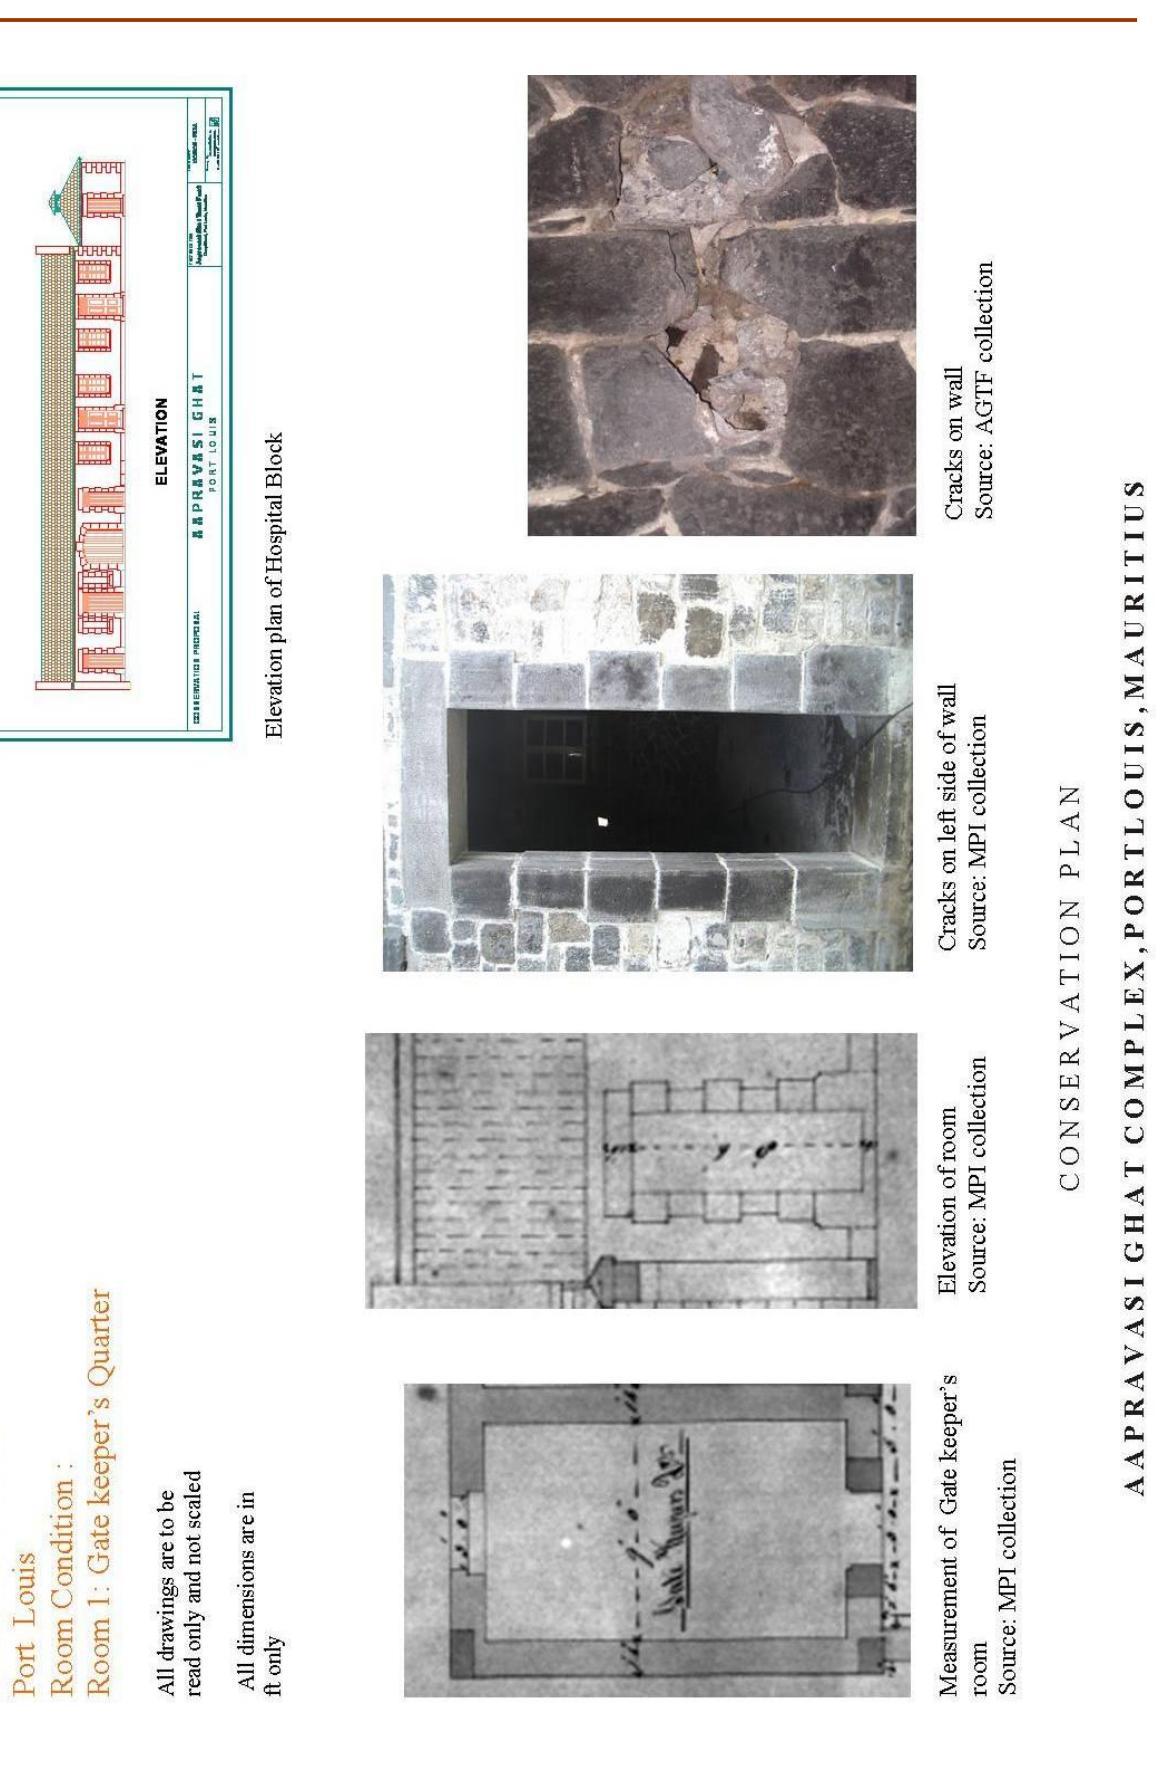
The general condition of the walls in room one do not show much sign of stress or deformation. It is noticed that the lintel of the window has been covered with thick cement mortar. This cement mortar has to be removed carefully with hammer and thin chisels in order not to damage what may be left of the original lintel materials.

The modern window shutter needs to be replaced by a window shutter of the same model and dimensions of the MPI plans of 1865.

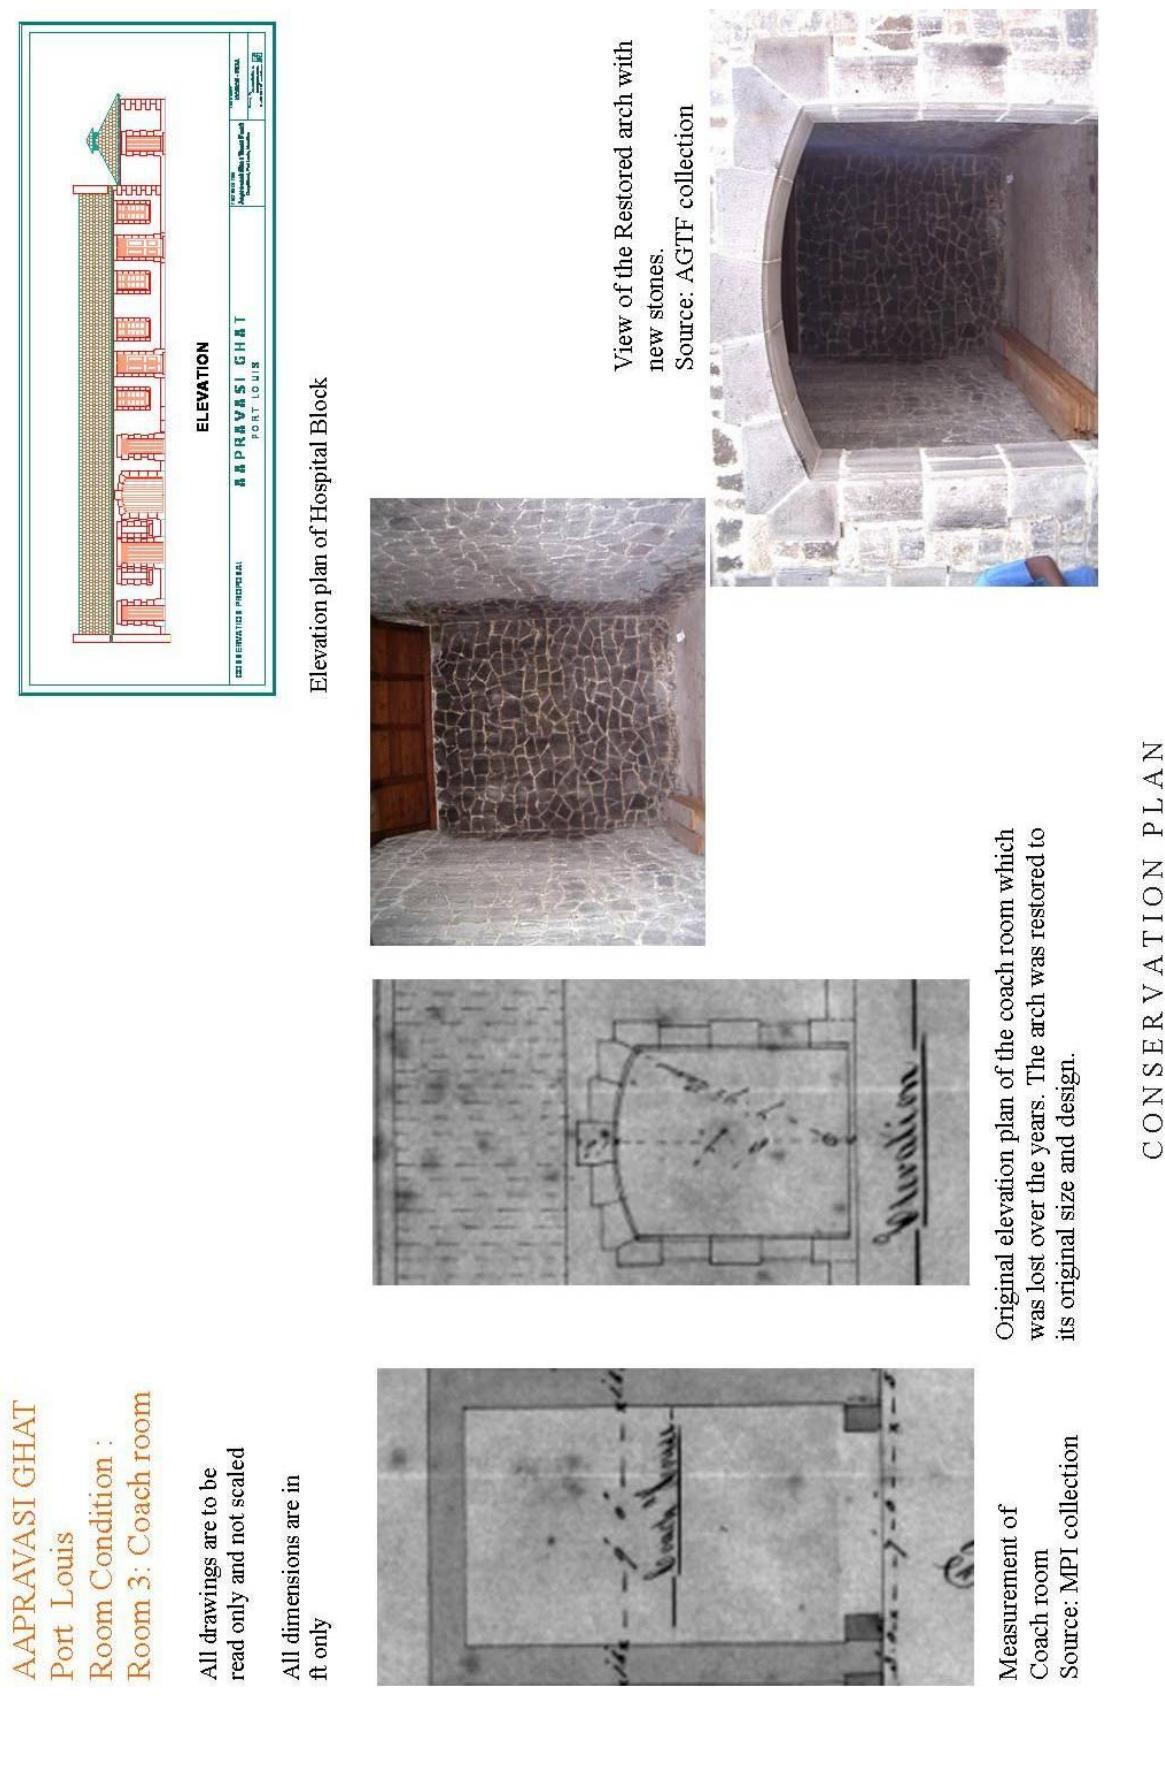
The overall condition of the room shows no signs of stress or deformation from load. There no signs of decay as well. The walls found in the coach room shows resistance to torsion, tension, compression, bending and shearing. The cement mortar has been removed from the joints to prevent damage to the walls. There are no visible cavities in the walls and it can be said that the original structure of the walls have survived the ravages of stresses.

Lime pointing is major conservation work to be done in the coach room since there are some stones which are getting loose.

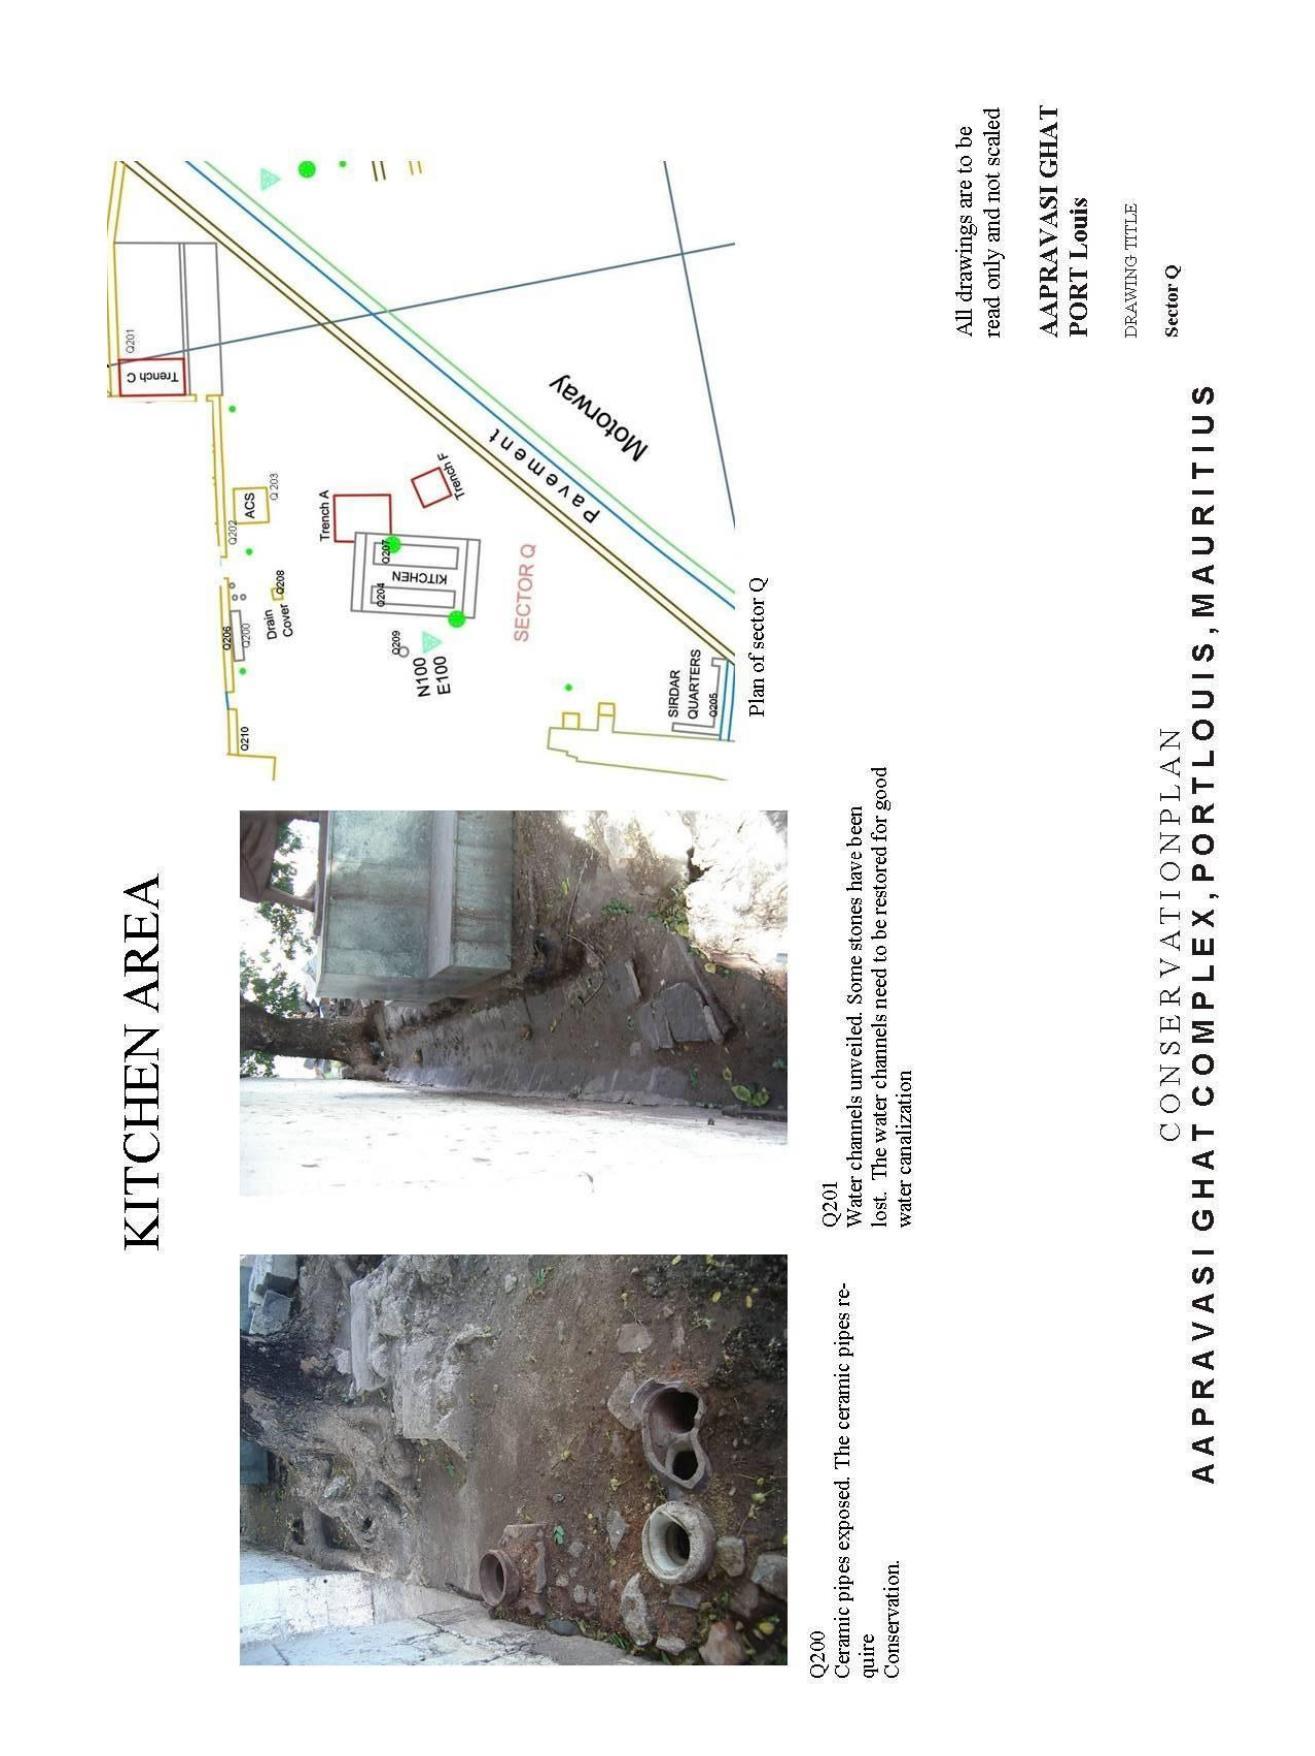
The base has been consolidated with lime mortar. Temporary sand slopping has been placed on the kitchen surface to prevent water logging. This has to be removed and a proper sloping be made with earth and mortar.

One striking feature found on the kitchen is the growth of two ashoka trees at two end corners. These ashoka trees threaten the integrity of the structure and have to be carefully removed in the recent future to prevent further damage to the structure.

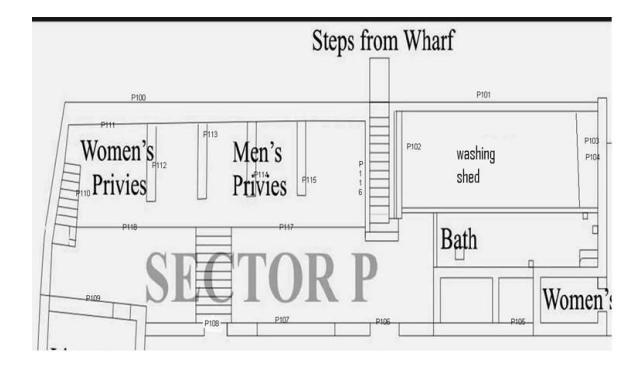
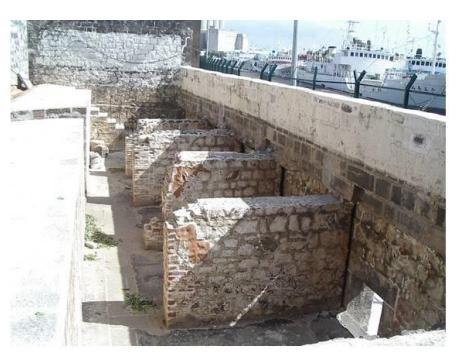
Overview of immigrant's privies

One noticeable thing is the growth of mosses and algae on the walls of the privies. This has affected large areas of the wall due to moisture in the walls. The algae needs to be removed by a fine brush carefully and water based silicone needs to be spread on these walls to stop water penetration.

At present, the process of laying a transparent plastic sheet on top of the privies is being studies with the Aapravasi Ghat consultants in order to preserve the privies from further deterioration.

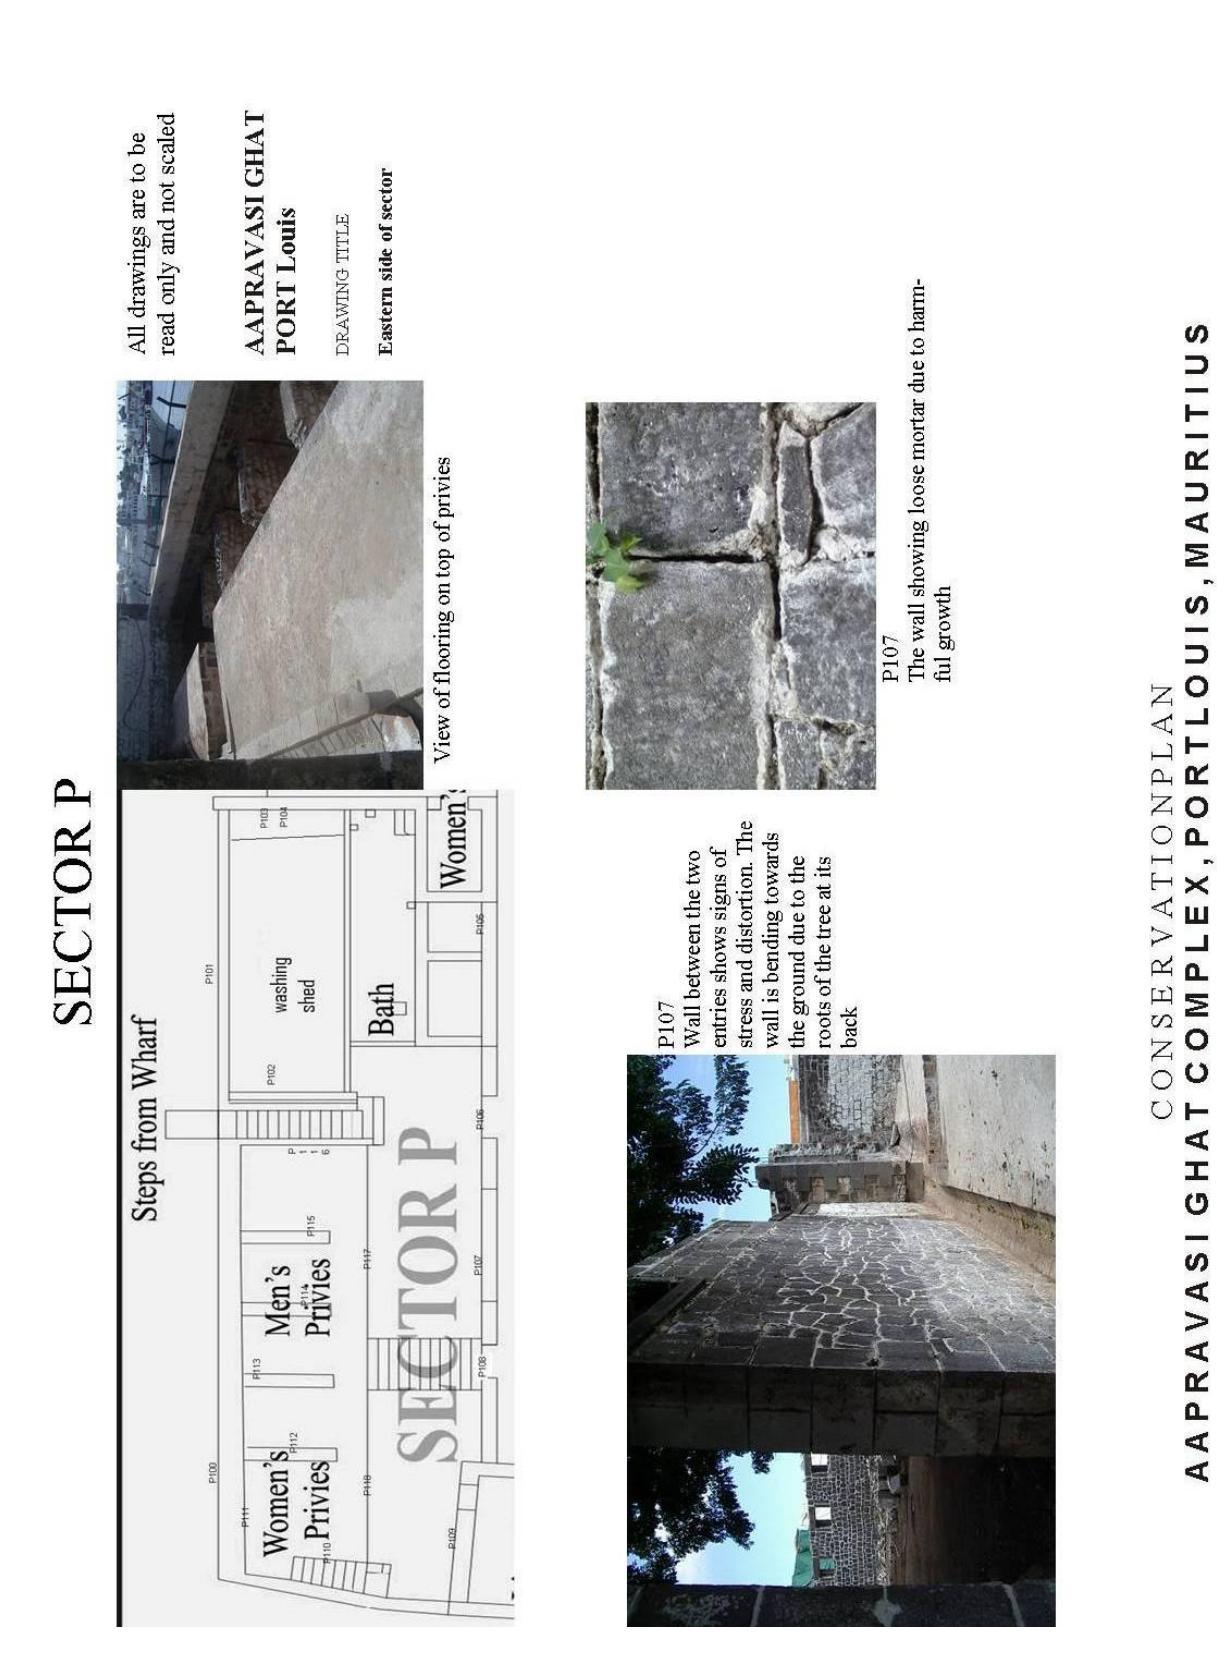
All drawings are to be read only and not scaled Vegetation growth is noticeable on the eastern side of the washing shed. Two major diagonal cracks are being seen coming from the wall due to the vegetation The cracks found in the walls are part of the continuing process of adjustment to continually varying loads due to thermal and moisture movements and wind.

Defects are noticeable on parts of the walls due to disintegration of binding materials and moisture. Decay is inherent in the very nature of the irregular bonded wall types in the extension shade wall. The vegetation and branches on top of the wall have to be removed. A quantum of water based silicone is required to be sprayed on the wall to stop further decaying.
